Field Moisture Performance of Wood-Framed Walls with Exterior Insulation in a Cold Climate

Research Paper
FPL-RP-698

March
2019

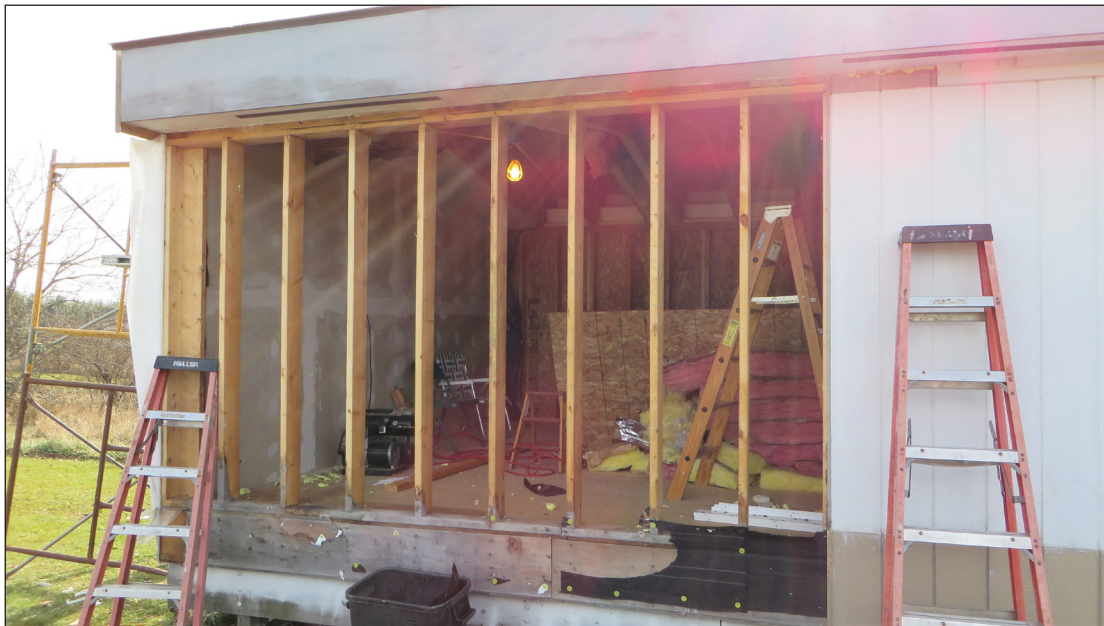
Figure 2. Northeast corner of test structure undergoing partial reconstruction.

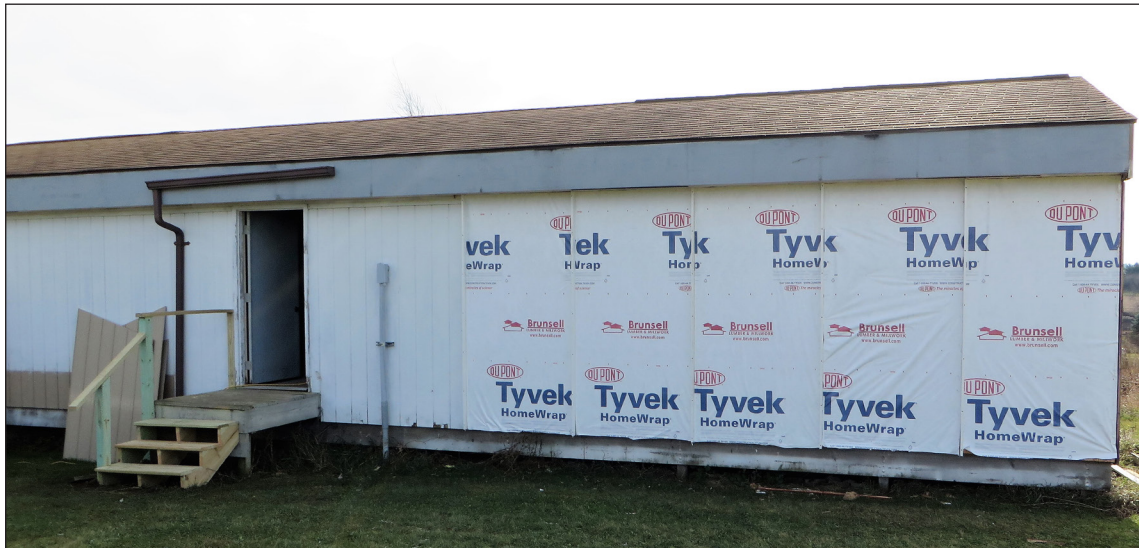
Figure 4. Northwest corner of test structure before installation of exterior insulation. The right-most section is not an instrumented section.

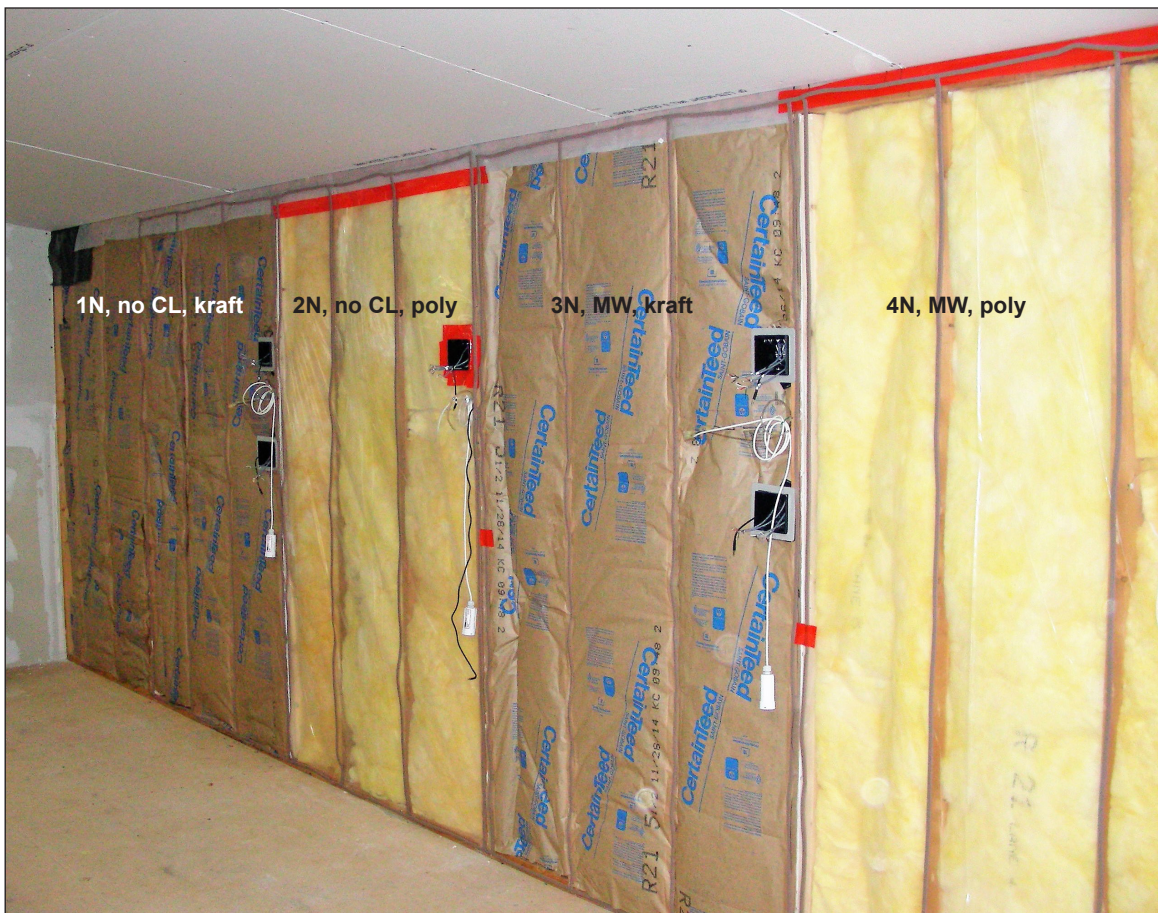
Figure 6. Northwest interior corner of test structure with wall cavities insulated before drywall installation (CI, continuous insulation; MW, mineral wool).

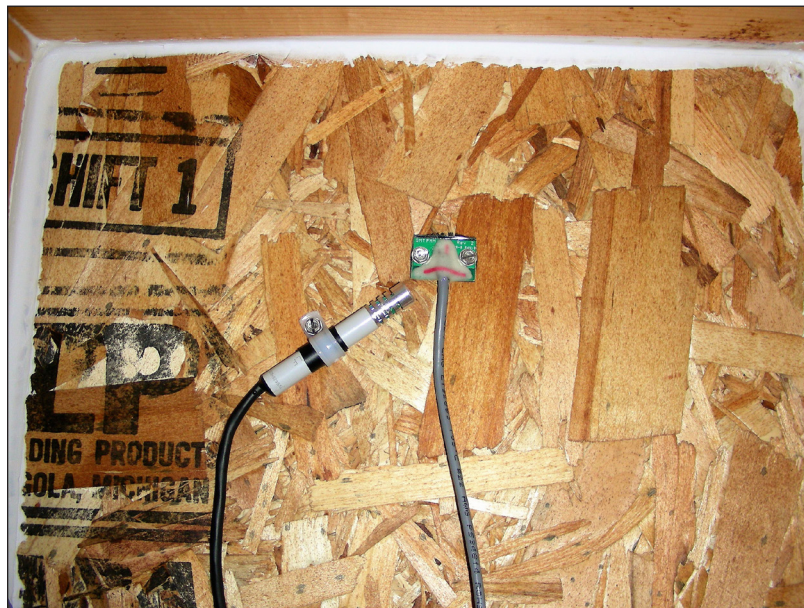
Figure 8. Instrumentation at top of cavity recording moisture content, relative humidity, and temperature.

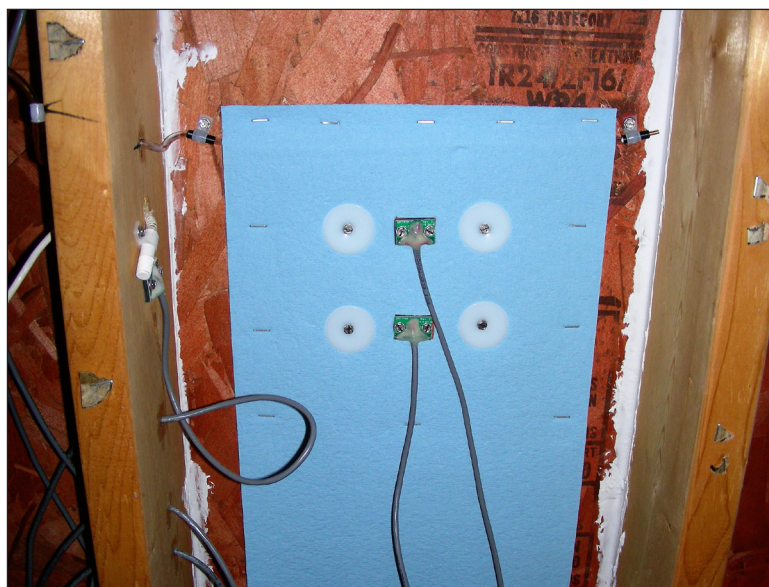
Figure 9. Water injection system.

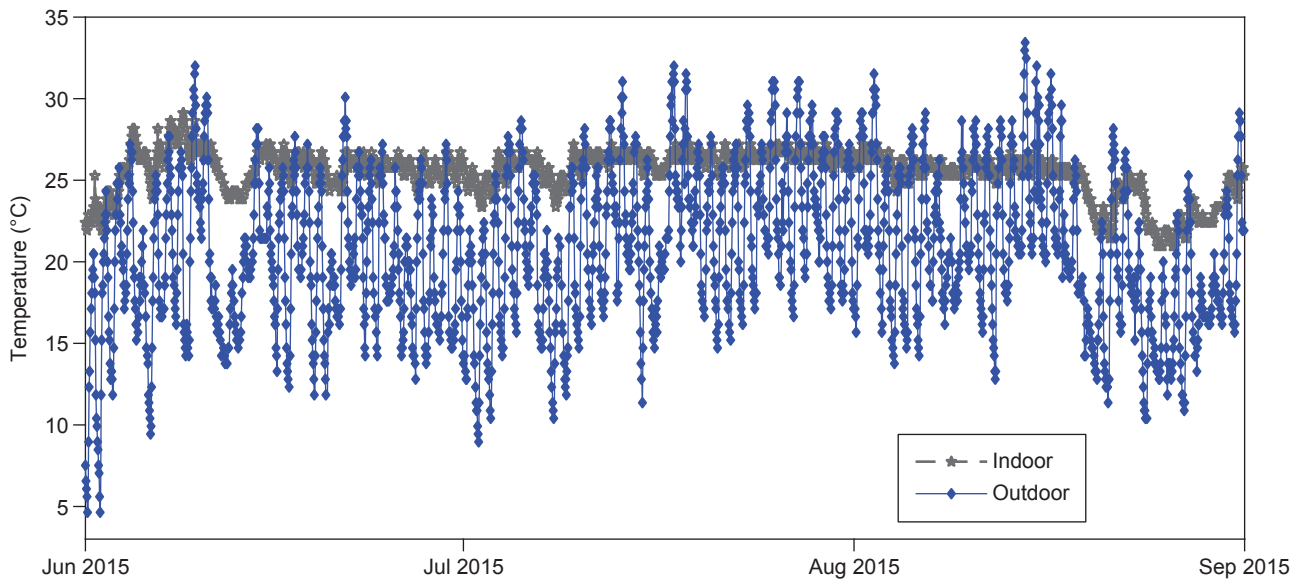
Figure 14. Hourly indoor and outdoor temperatures during summer.

with outdoor for the full 2 years, whereas Figure 14 shows the same data at an hourly level for the summer to illustrate exterior conditions cycling above interior during parts of the day.

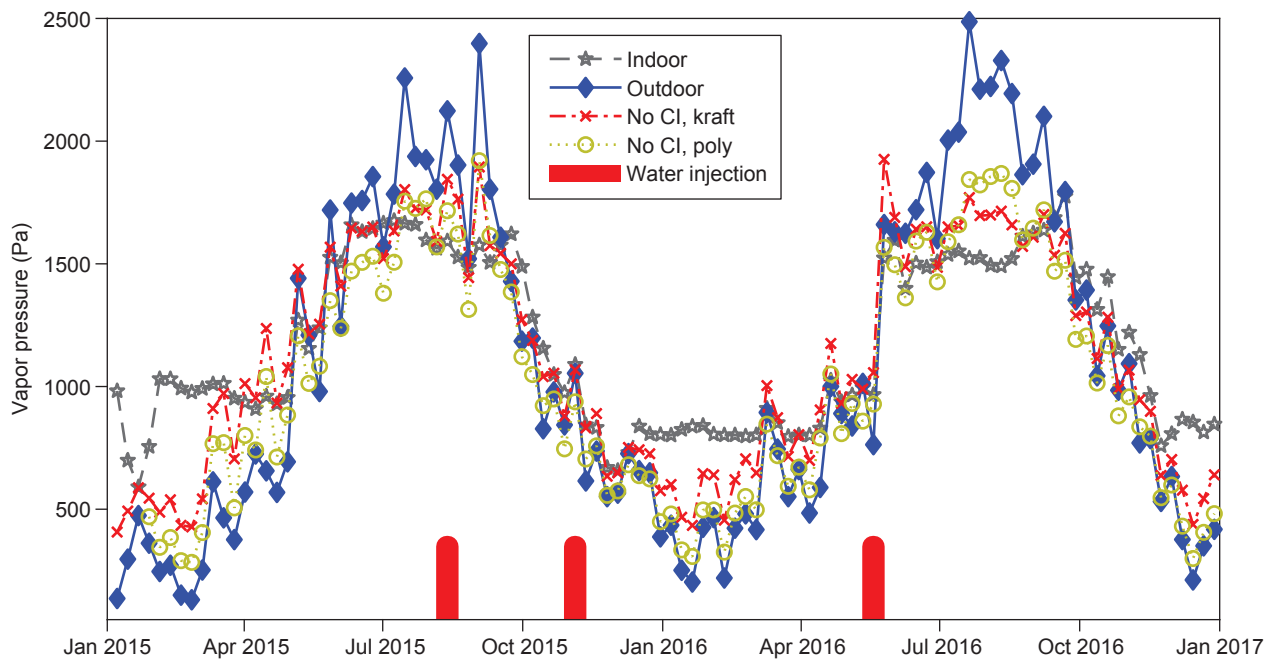
Figure 20. Vapor pressure in two north wall cavities compared with indoor and outdoor conditions (CI, continuous insulation).

Vapor pressures inside each cavity typically fell between the indoor and outdoor boundary conditions. Figure 20 illustrates this by plotting the weekly average vapor pressure calculated using Equation (1) from the RH and temperature readings of the HOBO sensor (midheight in the cavity at mid-depth) for the two base case north walls along with indoor and outdoor conditions. Generally, the cavity with kraft vapor retarder was closer to indoor conditions. All the north wall cavity weekly average vapor pressures are plotted in Figure 21, which shows that the cavities with polyethylene vapor barrier had higher vapor pressure than cavities with kraft in summer and generally had lower vapor pressure than kraft cavities during winter. Figures 20 and 21 also show the timing of the water injections with the red bar at the bottom.
